# ASSESSMENT OF THE CITY'S EXISTING STORMWATER CONVEYANCE SYSTEM

**Report**

**City of Rocklin**

**Michael Baker International**

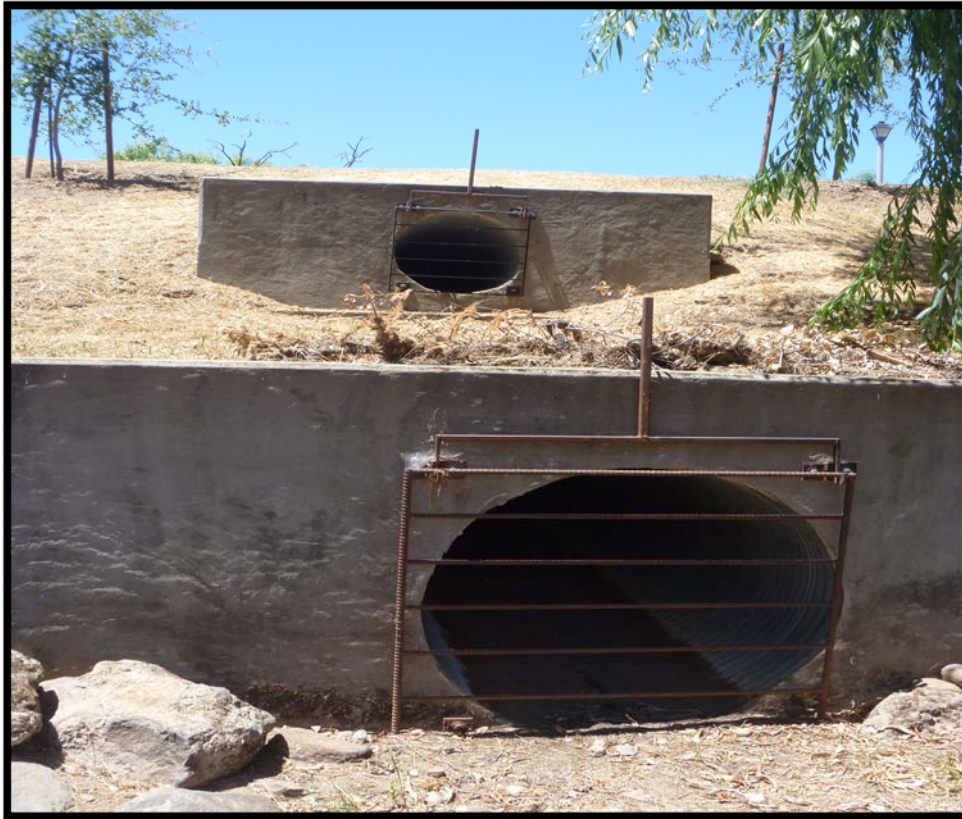
**Photo 1 – Structural Ranking of 5**

In order to clearly depict what a structural ranking of 5 looks like compared to a ranking of 1, example photos have been included herein. Photo 1 is an example of a structure with a ranking of 5 or good. The discharge pipes and screens are clear of debris, there are no breaks in the concrete, and all vegetation has been cleared from the vicinity. These structures are in good working condition and will function as designed.

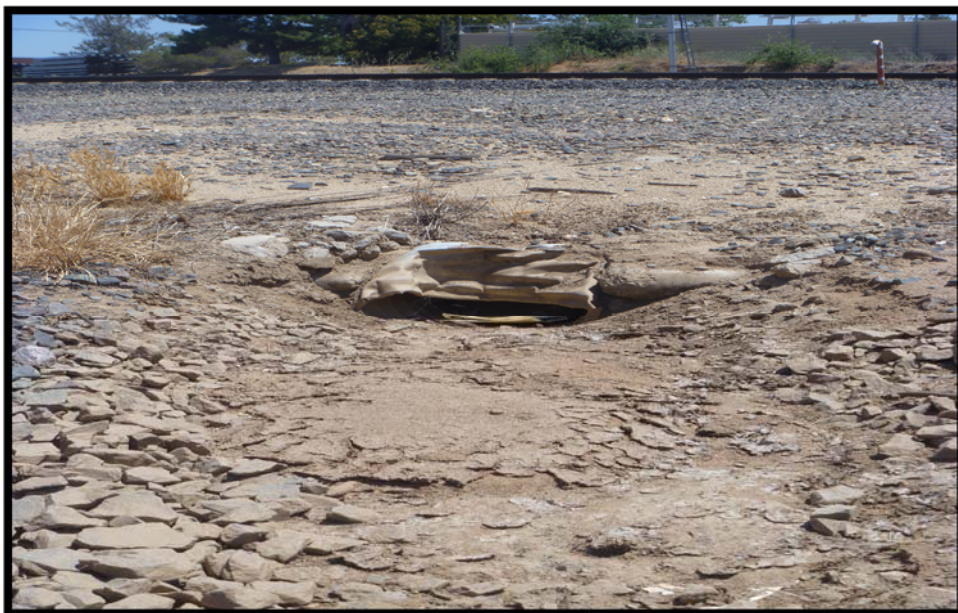
**Photo 2 – Structural Ranking of 1**

Photo 2 is an example of a structure with a ranking of 1 or poor. This structure is located in what is considered Old Town Rocklin. The pipe is deformed and collapsed in on itself, with debris inside and near the outlet. This facility will not function appropriately and should be repaired or replaced.

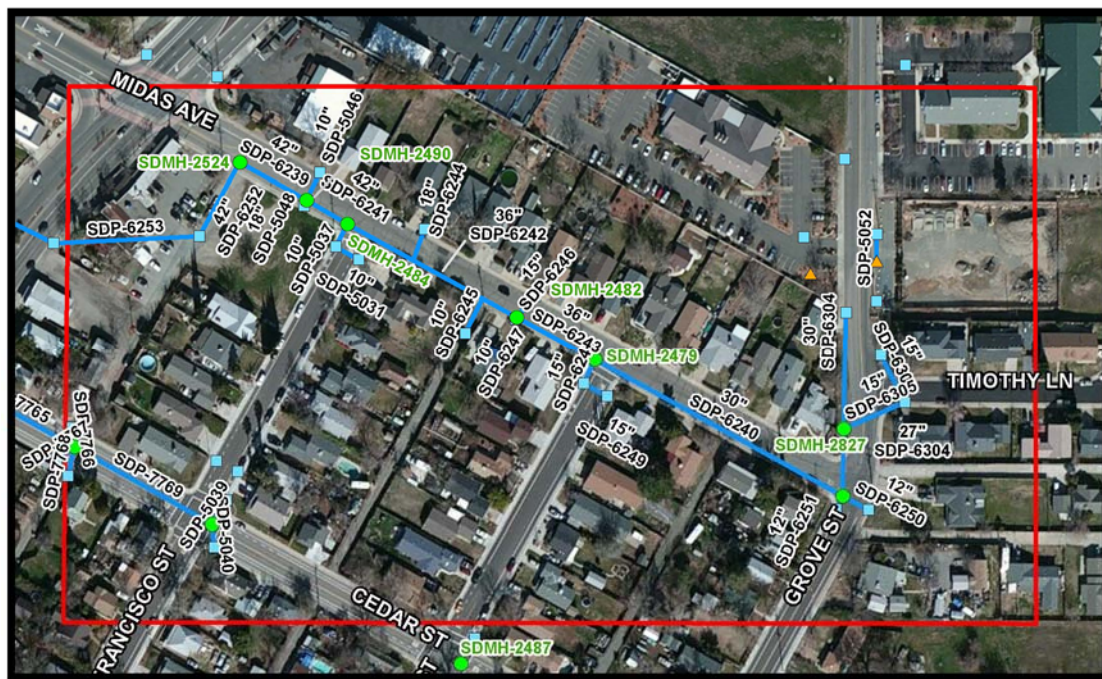
**Figure 1 – CCTV Area 1**

- Section 1 of Area 1 is between manholes SDMH-2827 and SDMH-2479 with a pipe diameter of 30 inches. No issues were cited in the CCTV report.
- Section 2 of Area 1 is between manholes SDMH-2479 and SDMH-2482 with a pipe diameter of 36 inches. At approximately 117 feet from SDMH-2479, infiltration leaking was detected near a joint.
- Section 3 of Area 1 is between manholes SDMH-2482 and SDMH-2484 with a pipe diameter of 36 inches. Slight sagging in the pipe was located approximately 242 feet from SDMH-2482.
- Section 4 of Area 1 is between manholes SDMH-2484 and SDMH-2490 with a pipe diameter of 42 inches. No issues were cited in the CCTV report.
- Section 5 of Area 1 is between manholes SDMH-2490 and SDMH-2524 with a pipe diameter of 42 inches. Multiple cracks were found approximately 44.1 feet into the pipe from SDMH-2490. The treatment of cracks could include a CIPP treatment.

The RCP in this area is approximately 35 years old. The CCTV inspection for Area 1 indicated that the overall life expectancy of RCP (90 years) is an appropriate assumption. Small areas may require attention, but this system is functioning appropriately and is not expected to deteriorate in the foreseeable future.

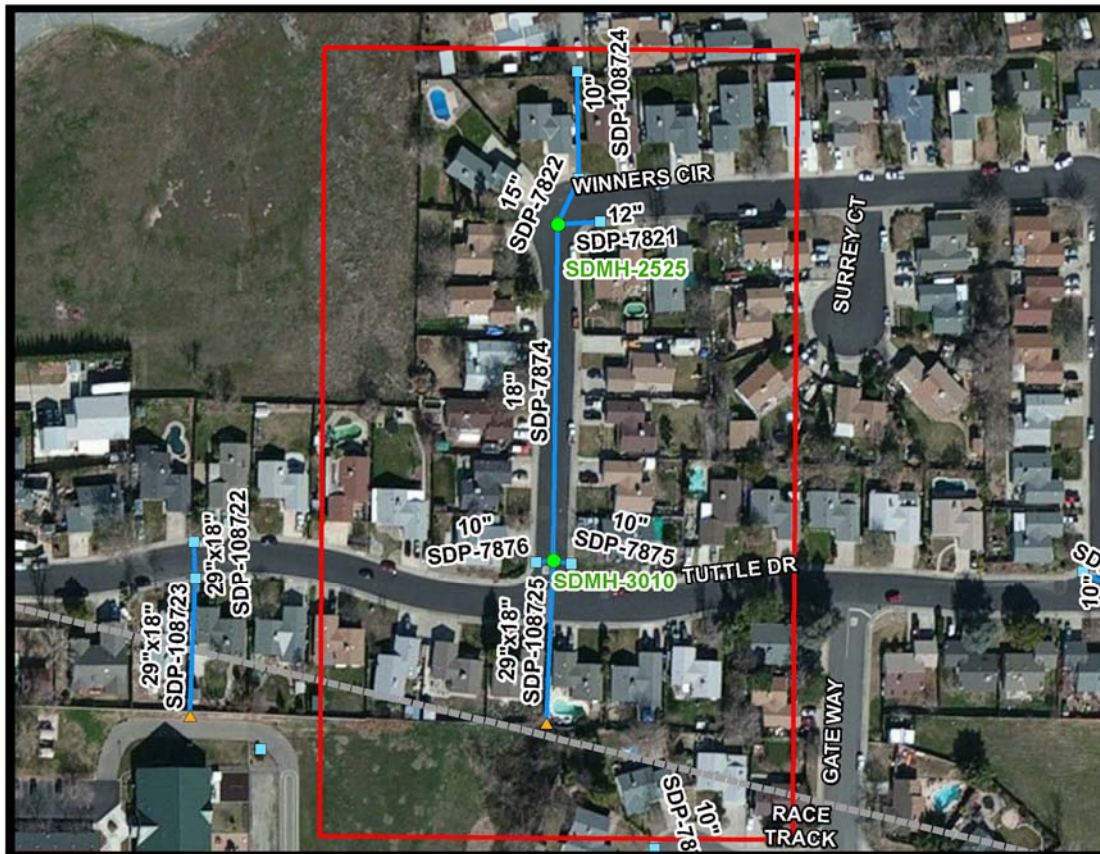
Figure 2 – CCTV Area 2

- Section 6 of Area 2 is between the Winners Circle inlet and manhole SDMH-2525 with pipe material of CMP and a pipe diameter of 15 inches. The survey began at the downstream manhole SDMH-2525. Due to severe debris, the survey was abandoned approximately 11 feet into the survey. It was also observed that the pipe was deformed.
- Section 7 of Area 2 is between an inlet located on Jamerson Drive and an inlet on Winners Circle. The pipe material of this section is CP and the pipe has a diameter of 10 inches; the pipe ID is SDP-108724. This portion of the survey began at the Winners Circle inlet. The survey was abandoned approximately 1 foot into the survey due to severe debris.
- Section 8 of Area 2 is between manholes SDMH-2525 and SDMH-3010. The pipe material of this section is CMP and the pipe has a diameter of 18 inches. This portion of the survey

began at manhole SDMH-2525 but was abandoned approximately 290 feet into the system due to severe debris. Deformation of the pipe was reported as well as surface corrosion.

- Section 10 of Area 2 is the reverse of Section 8. The survey began at manhole SDMH-3010 and proceeded upstream toward manhole SDMH-2525. The Section 8 inspection was abandoned due to severe debris approximately 290 feet downstream of SDMH-2525. The diameter of this section is 18 inches. This section was also noted to have severe deformation in the pipe, with approximately 25% of the cross-sectional area full of debris.

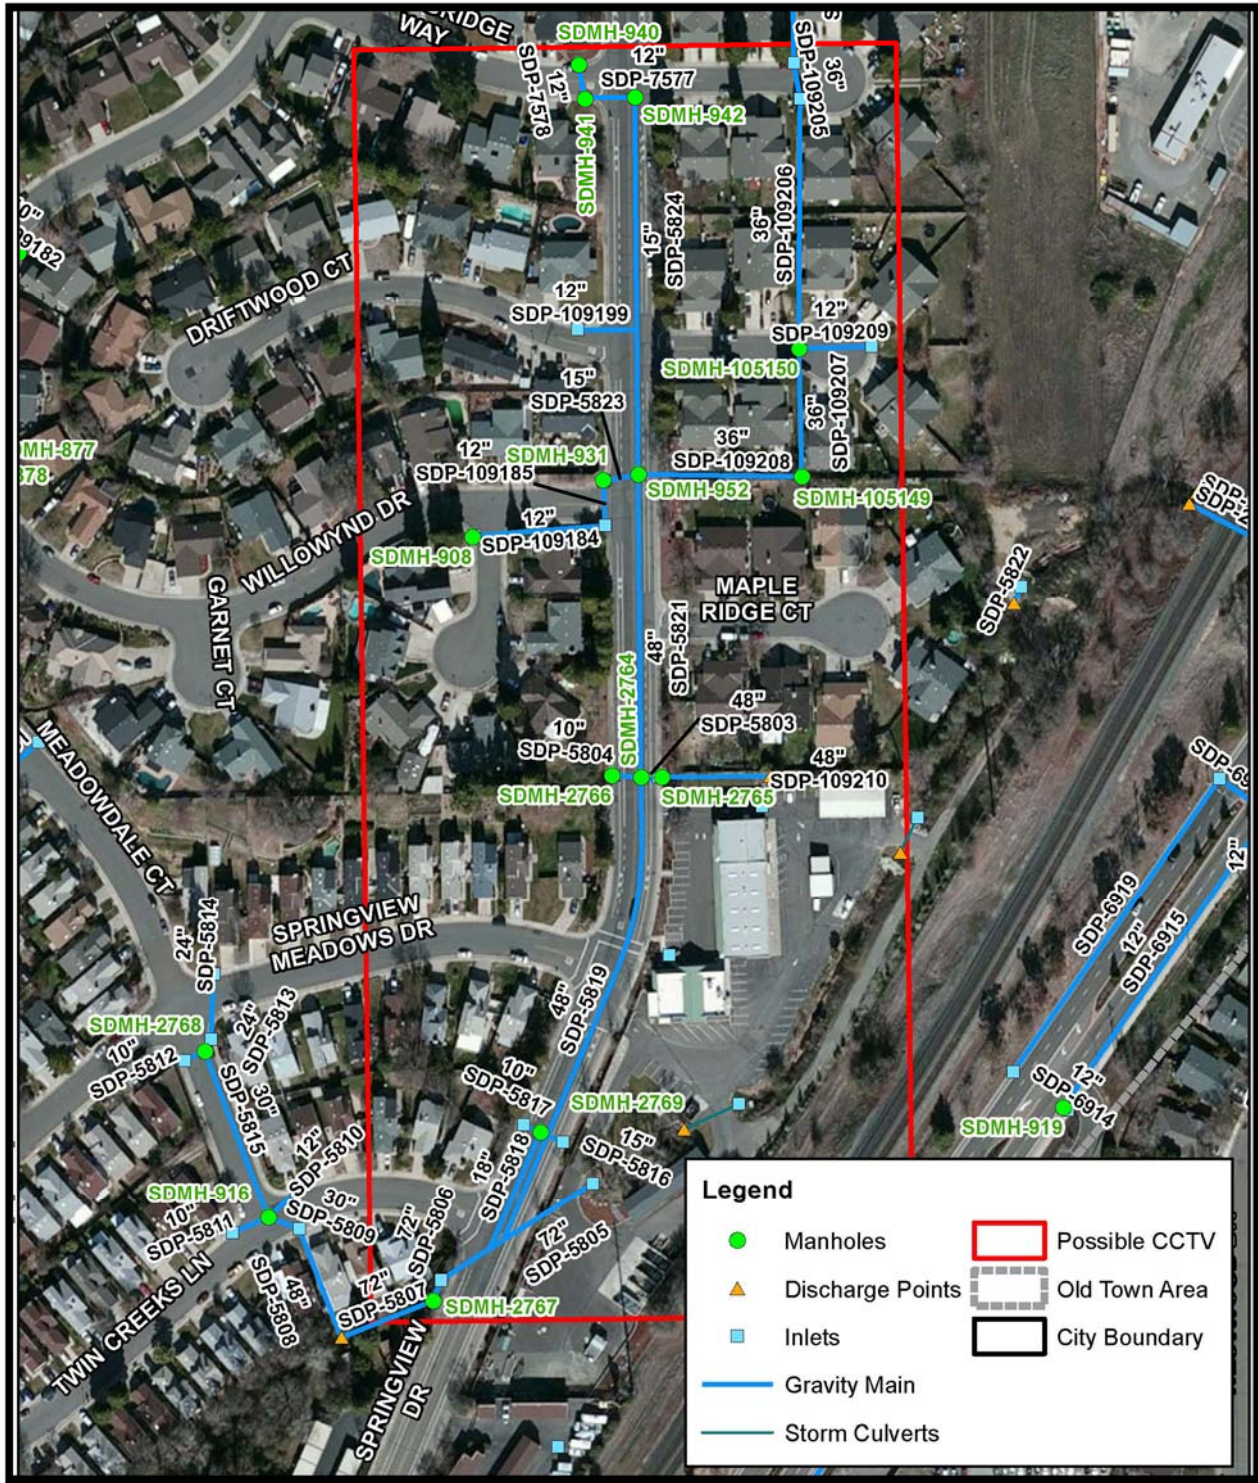
Figure 3 – CCTV Area 3

- Section 8 of Area 3 is between manholes SDMH-952 and SDMH-2764. The pipe has a diameter of 48 inches. It was observed that the system had a water level of 10% of the cross-sectional area at the time of inspection. Settled gravel and settled compacted deposits were found starting at approximately 125 feet in from SDMH-952.

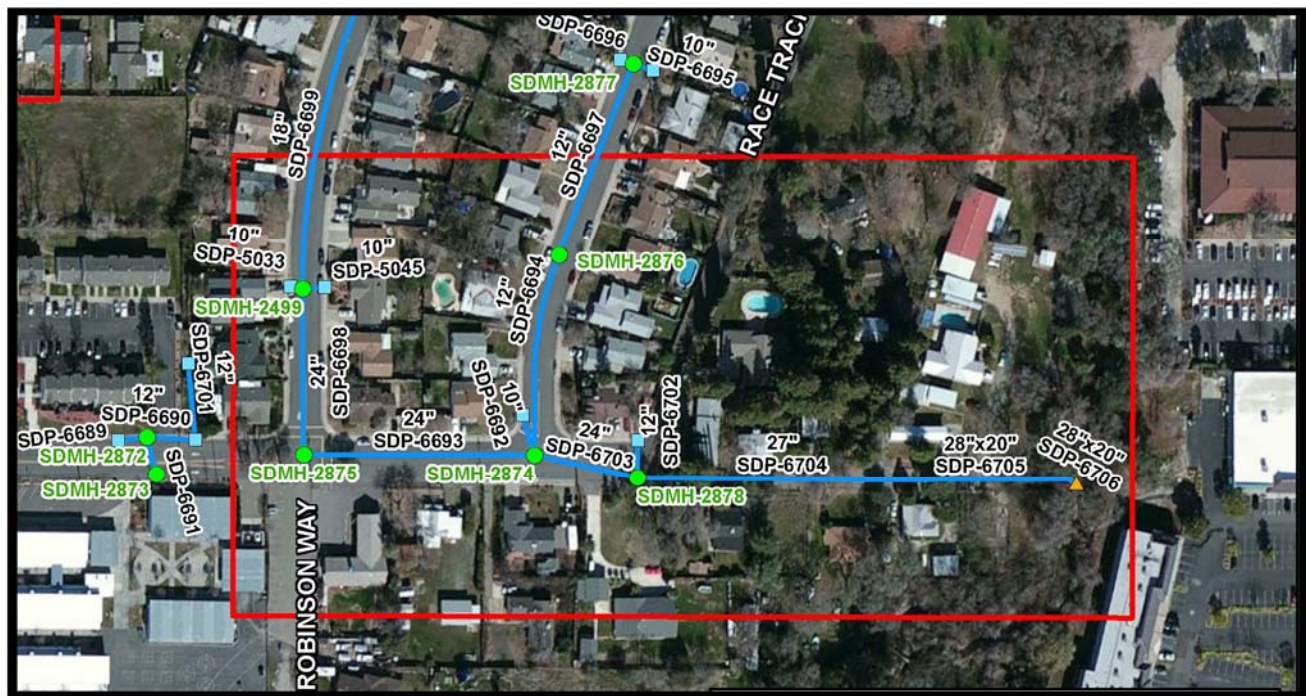
**Figure 5 – CCTV Area 5**

- Section 5 of Area 5 is located between manholes SDMH-2875 and SDMH-2874. The pipe has a diameter of 24 inches. Debris in the system was observed to be 5% to 15% of the cross-sectional area in various locations throughout the system. Roots growing into the pipe were located approximately 215 feet from manhole SMDH-2874 near a joint.
- Section 6 of Area 5 is located between manholes SDMH-2874 and SDMH-2878. The pipe has a diameter of 24 inches. Roots were located approximately 7 feet from manhole SDMH-2874. Debris was noted to accumulate in approximately 10% of the cross-sectional area. Manhole SDMH-2878 has been paved over, preventing access. A slip line could be used to repair this section.
- Section 7 of Area 5 is located between manhole SDMH-2878 and the discharge outlet. The pipe has a diameter of 27 inches. This section of pipe joints has been slightly damaged by roots.
