## **Arborist Report & Tree Inventory**

Rocklin Fire/Quarry Adventures Park  
Rocklin, CA

**Omni-Means, Inc.**

March 29, 2017

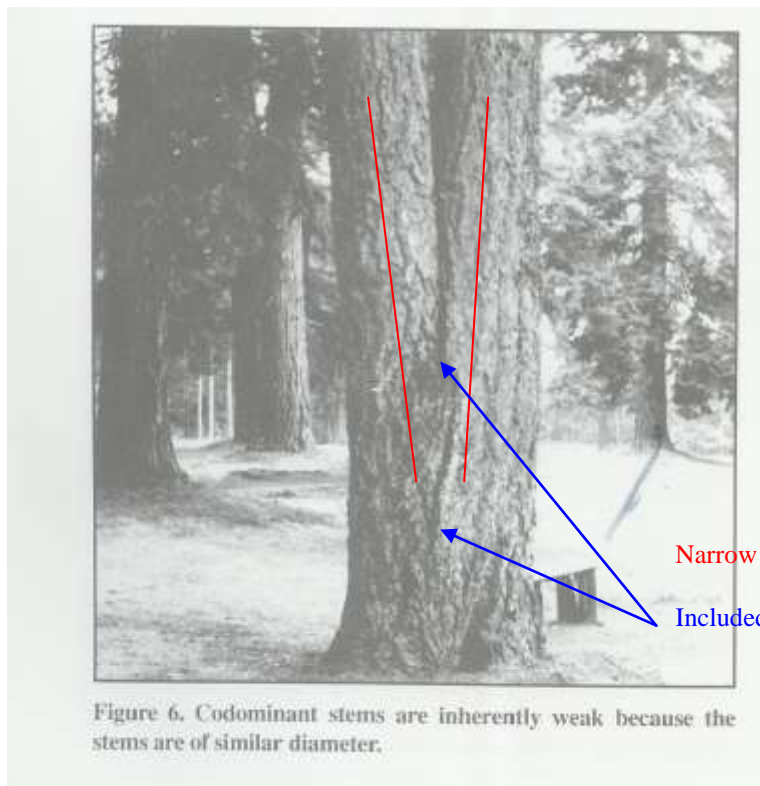
The tree in this picture has a co-dominant leader at about 3' and included bark up to 7 or 8'. Included bark occurs when two or more limbs have a narrow angle of attachment resulting in bark between the stems – instead of cell to cell structure. This is considered a critical defect in trees and is the cause of many failures.
