Wildlife Species Observed within The College Park Study Areas

4. Arborist’s Recommendation for Removals

Appendix C – Photos

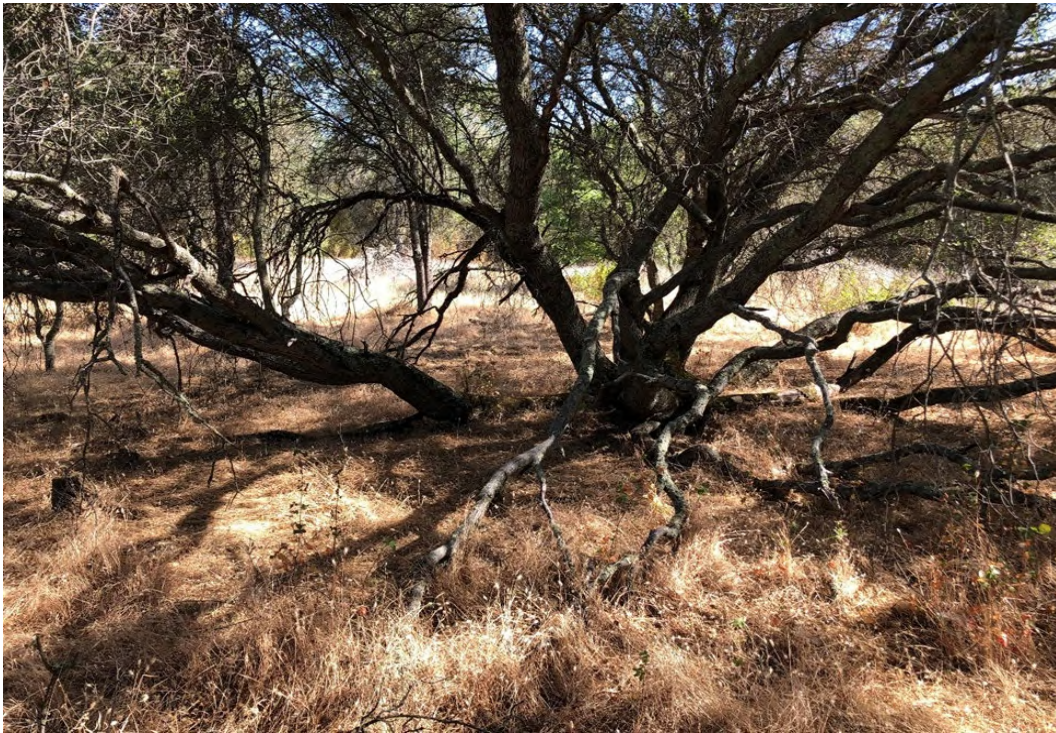
Photo 3: Typical multi-stem Live oak.

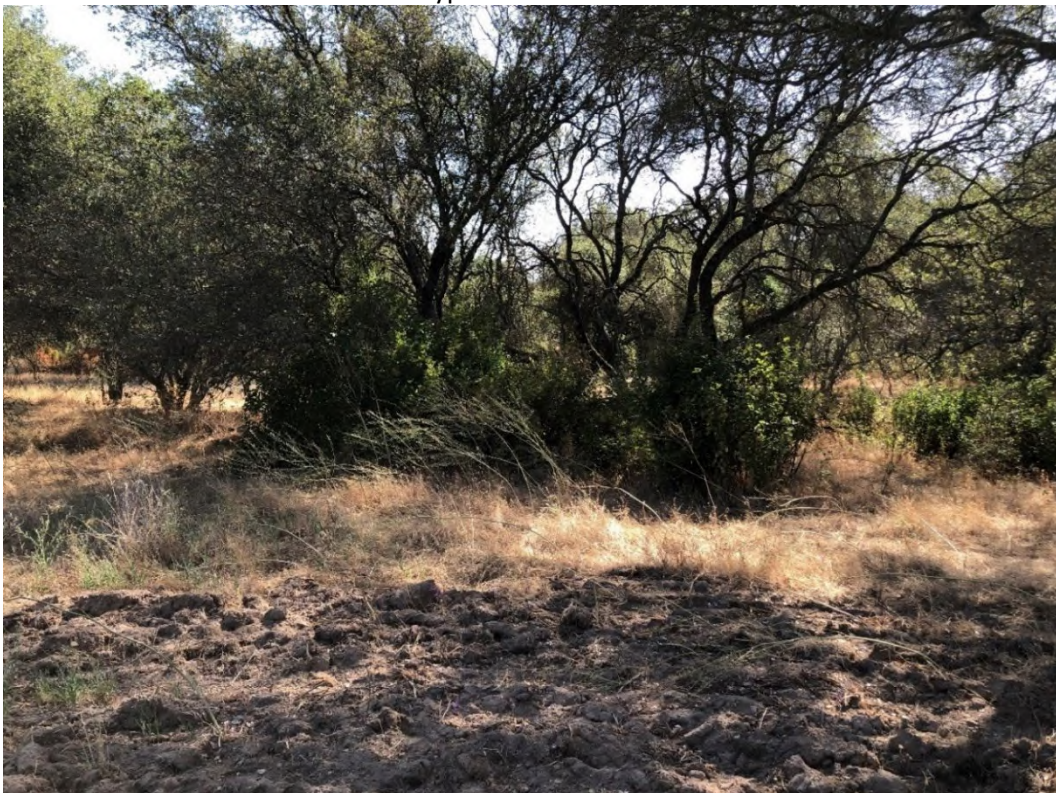
Photo 4: Large multi-stem tree.

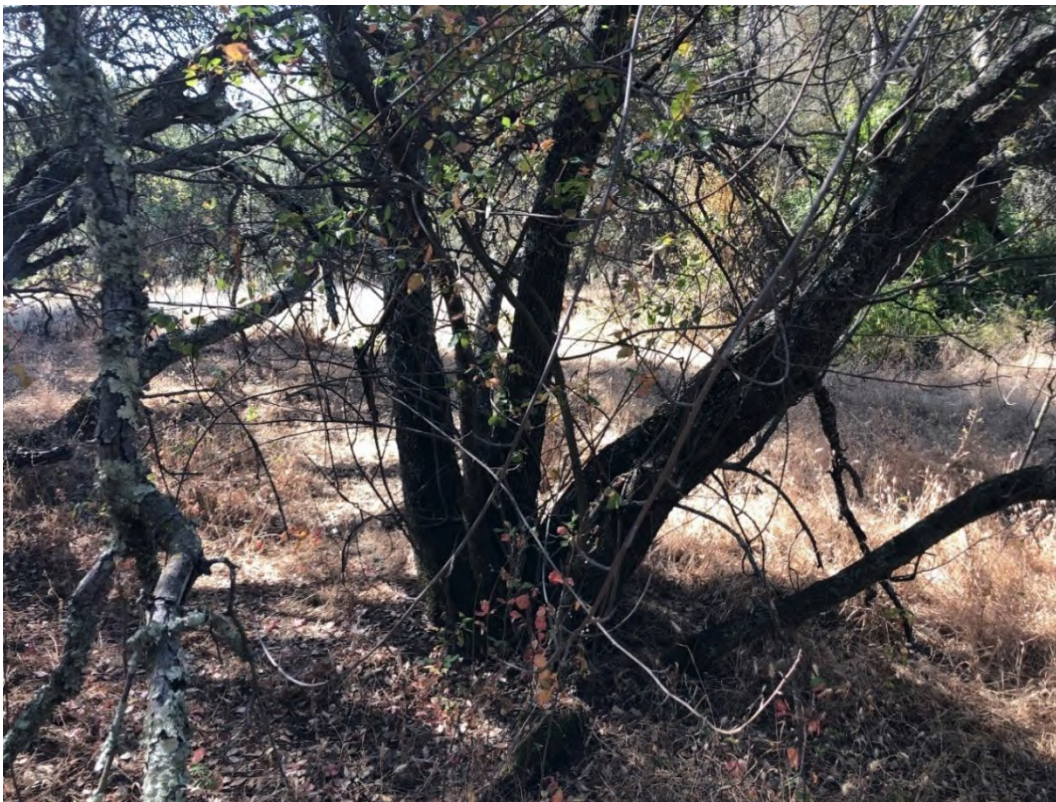
Photo 6: Five trees appear as one or two.

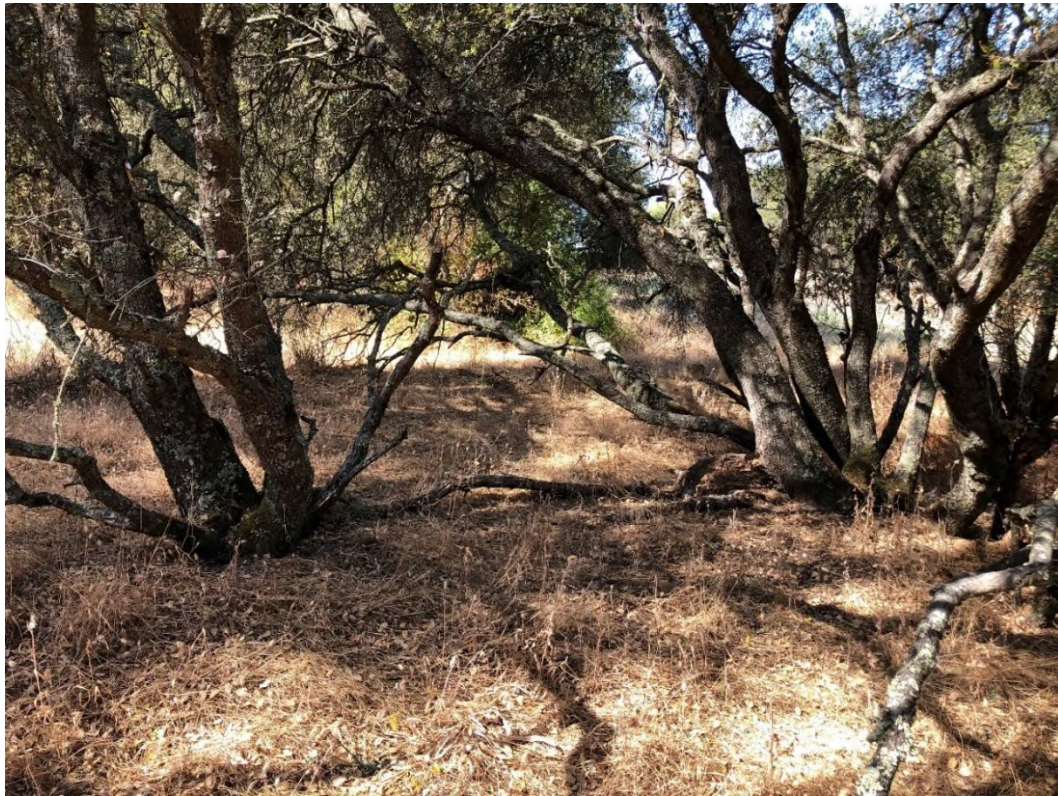
Photo 7: Multi-stems, weak attachments, overly dense.

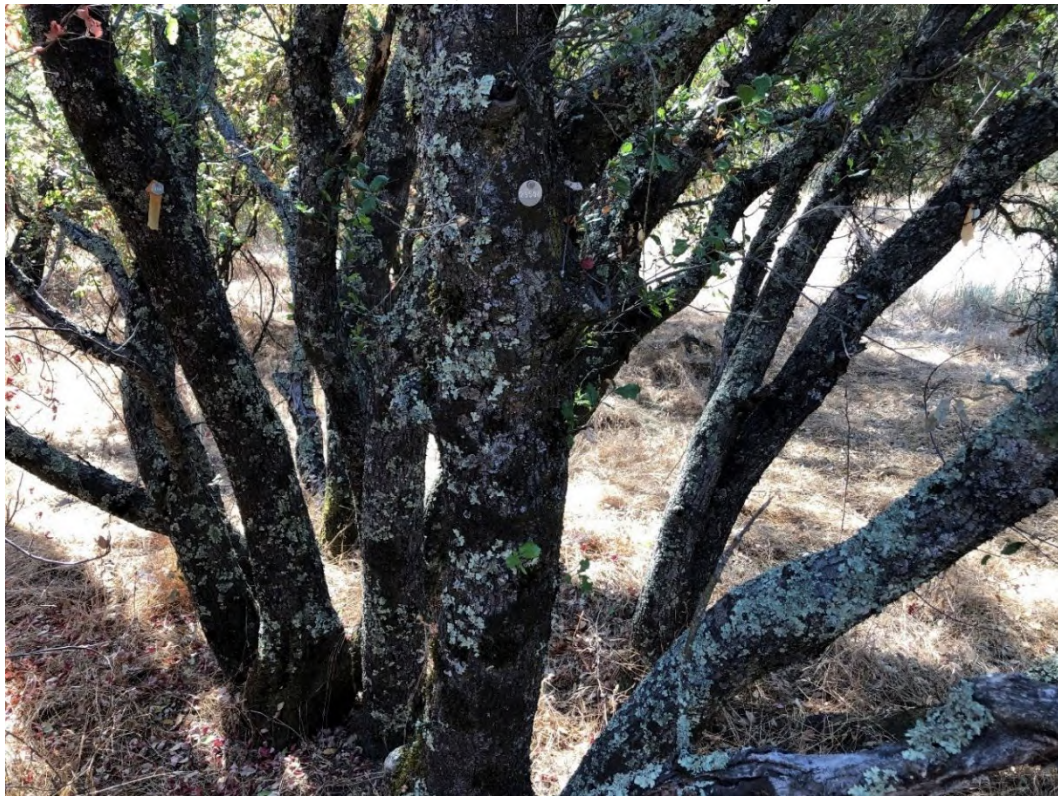
Photo 8: Four trees in photo. Note density and weak attachments.

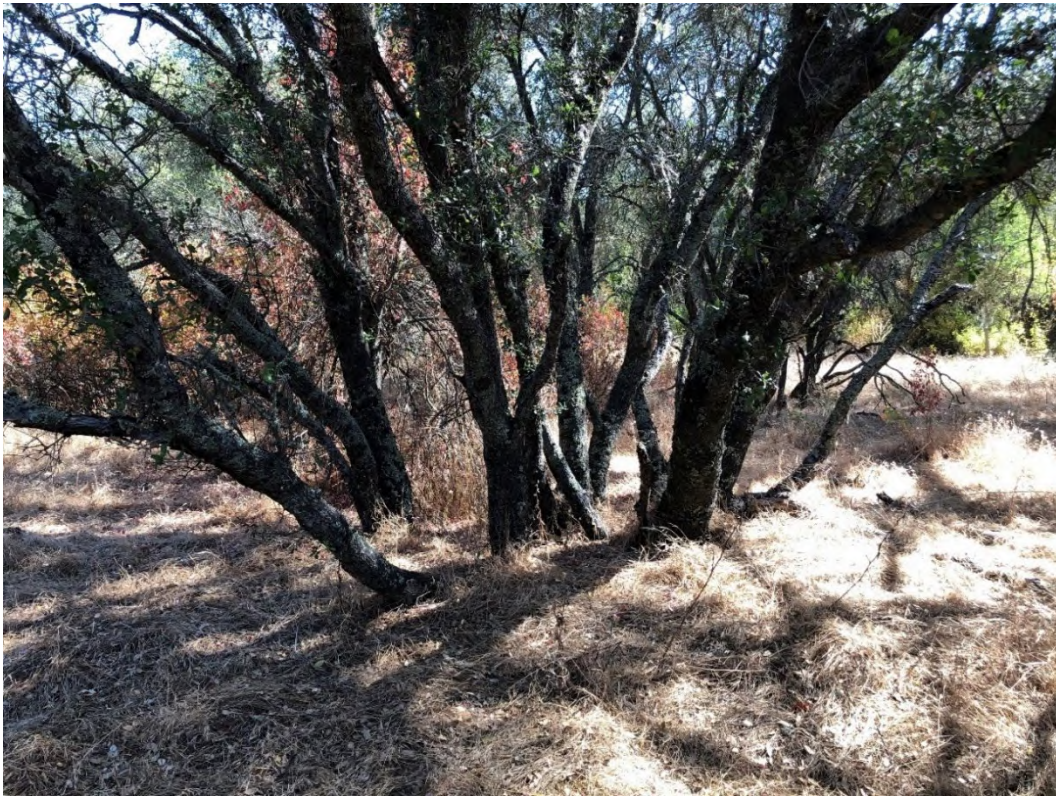
Photo 9: Same trees as previous photo

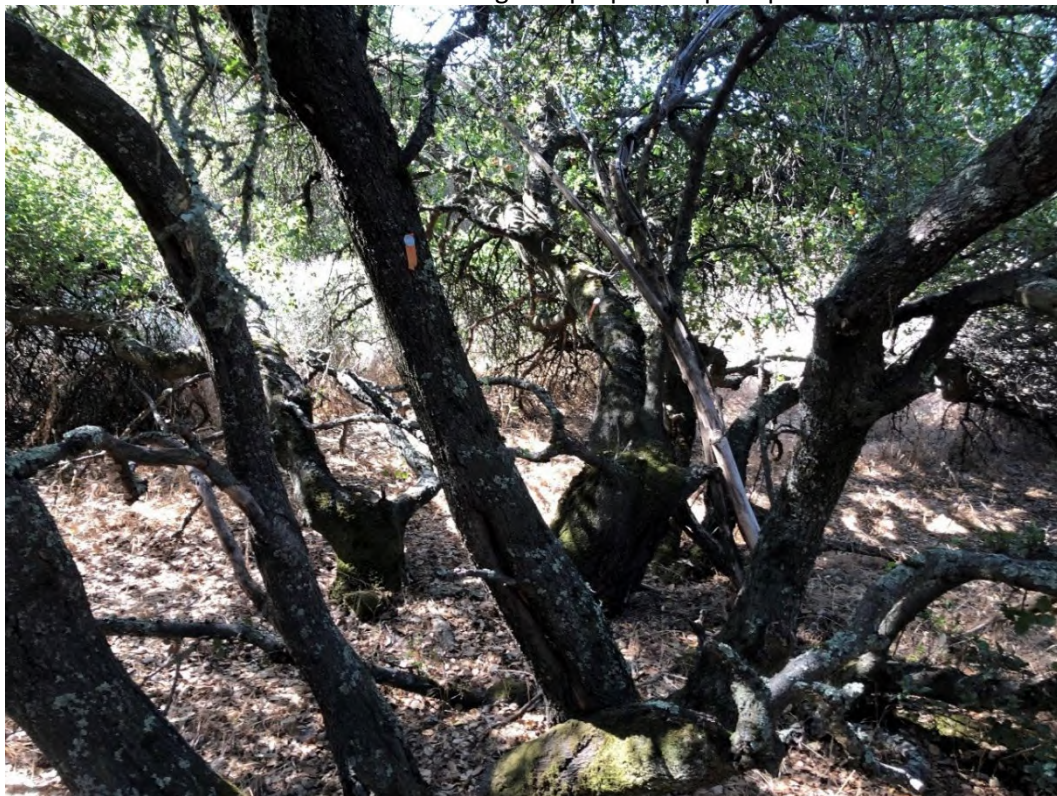
Photo 12: Typical, note basal defects, excessive dead wood, and poor structure.

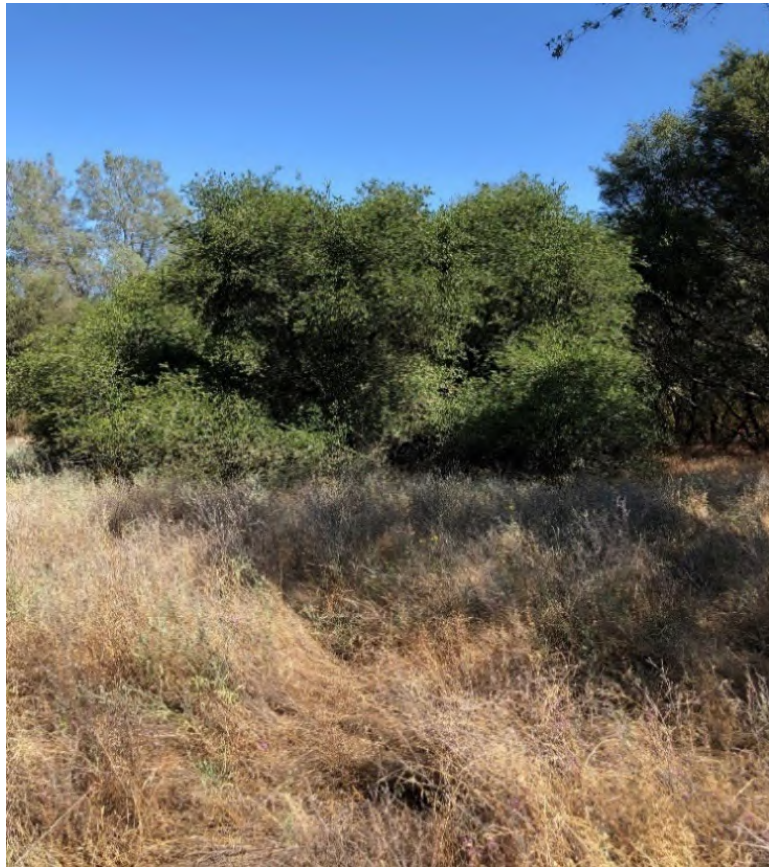
Photo 13: Small multi-stem Live oak.
