## **3.4. City-maintained trees along streets and parkways**

### 3.4-City-Maintained Trees along Streets and Parkways

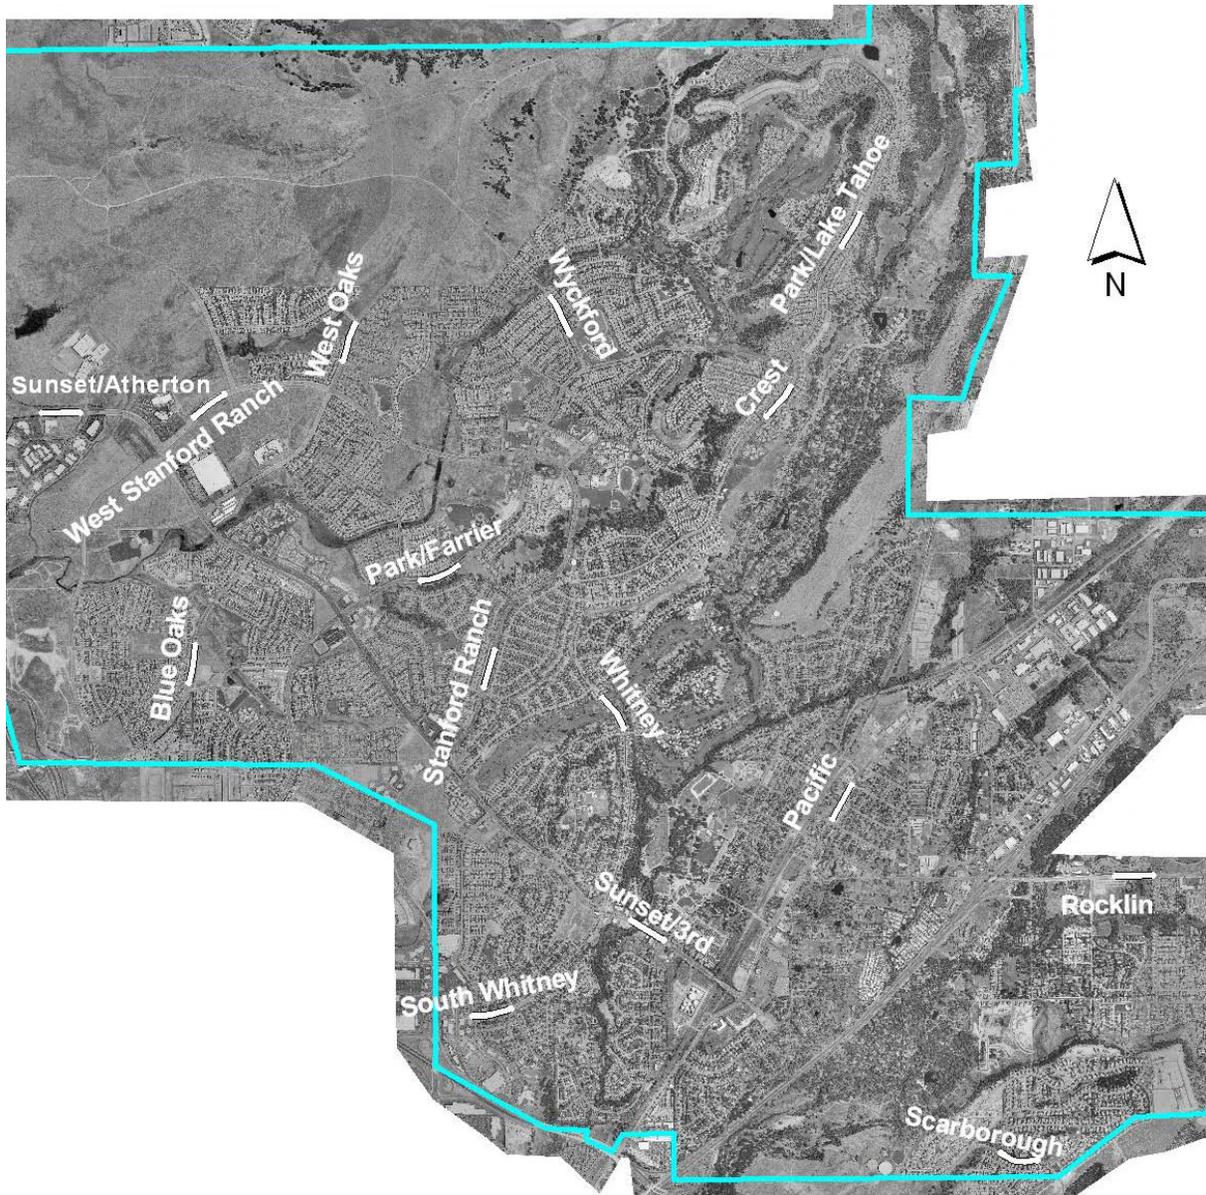
**Figure 3.4-1. Locations of street segments (white lines) included in the survey of City-maintained street trees (background: 2003 aerial photo).**

The street segments included in our survey of Rocklin's City-maintained street landscaping are listed in Table 3.4-1 and illustrated in Figure 3.4-1.

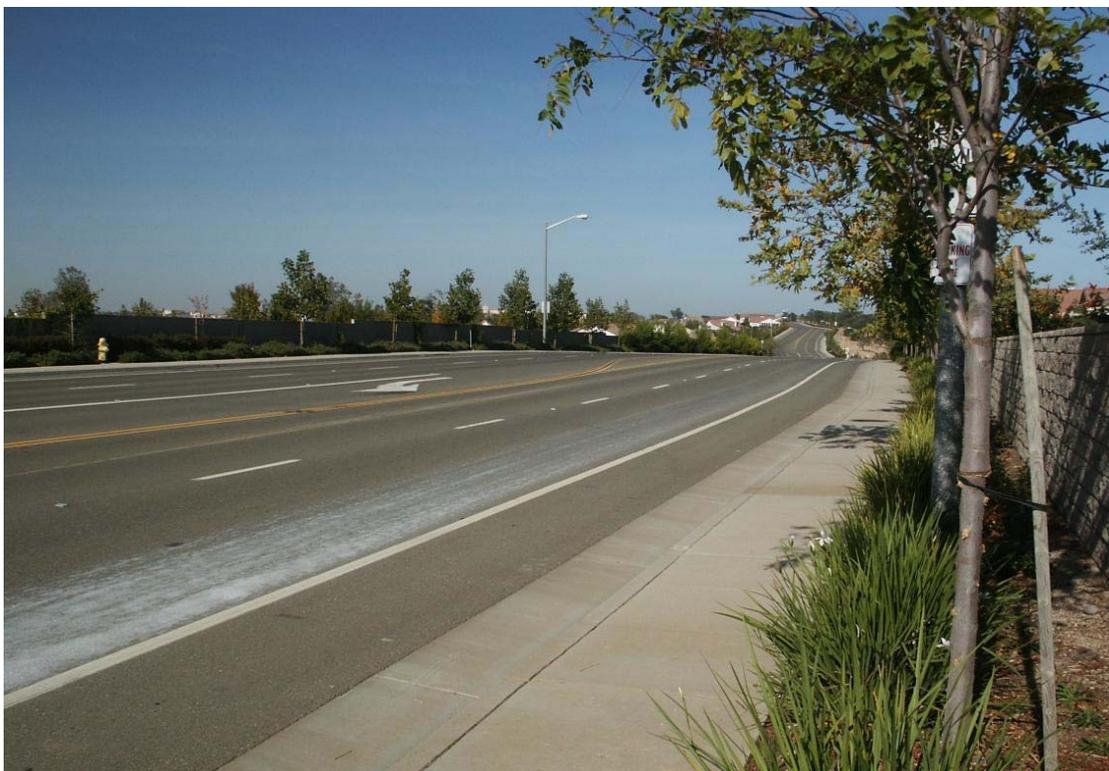
**Figure 3.4-2. Narrow City-maintained shoulder plantings along Park Drive near Lake Tahoe Ct. No center median plantings are present in this area.**

Only two of the surveyed segments did not include planting beds in the medians (Figure 3.4-2). Five did not include shoulder plantings either because the areas were undeveloped (e.g., W. Stanford Ranch Rd.) or because the street shoulders were lined by residential front yards (e.g., Whitney Blvd., Figure 3.4-3) or commercial properties (e.g., Sunset near 3<sup>rd</sup>, Figure 3.4-4).

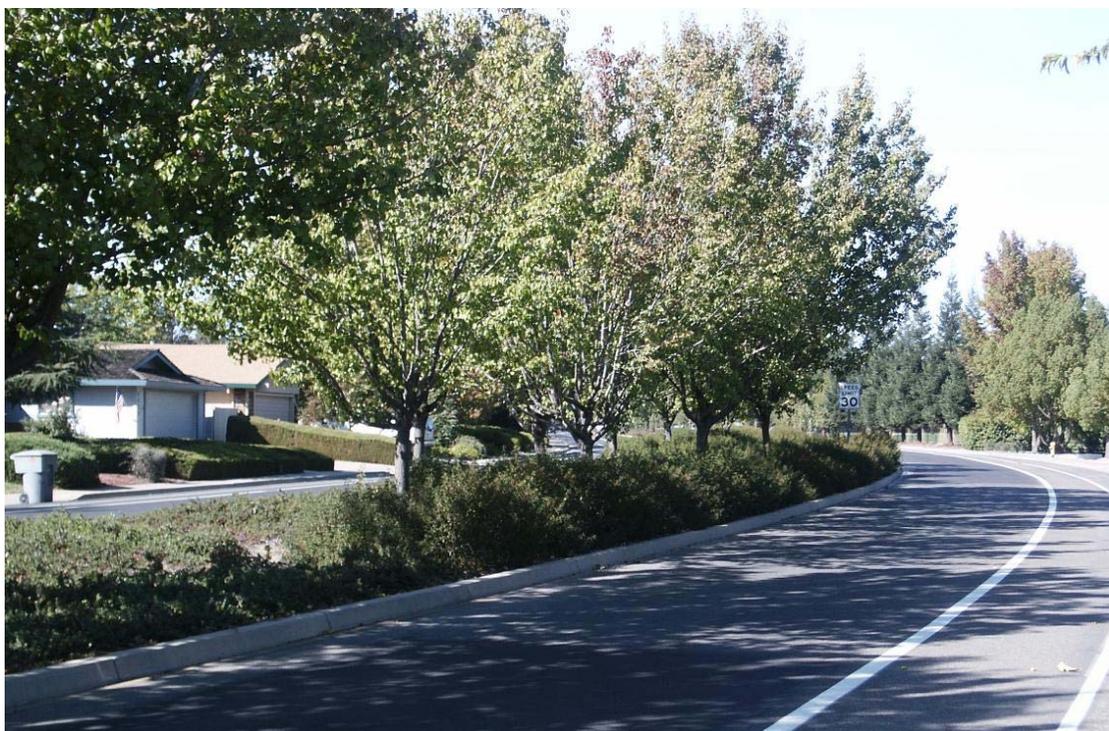
**Figure 3.4-3. City-maintained center median planting along Whitney Blvd. Shoulder areas are not City-maintained and include residential front yards and plantings along the golf course.**

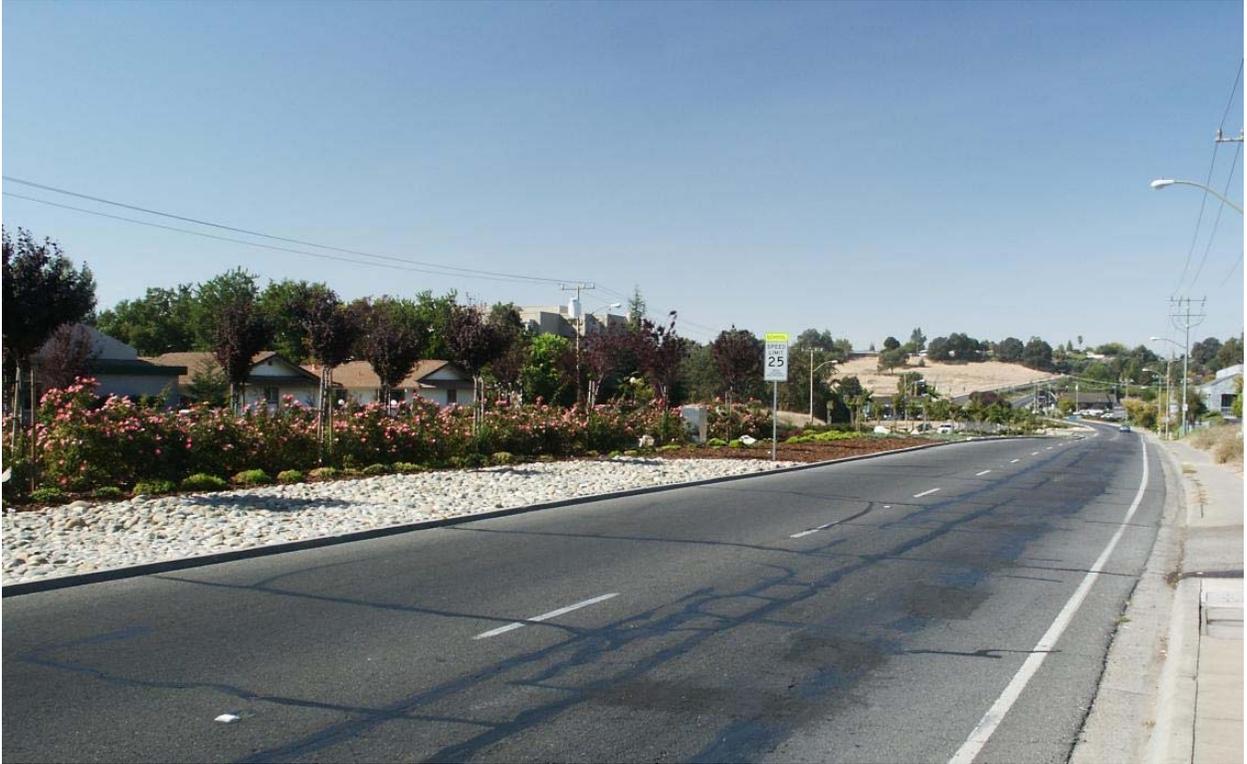
**Figure 3.4-4. Trees in center median on Sunset Blvd. near 3<sup>rd</sup> Street include a double row of purple leaf plums. Trees are situated to accommodate future widening of the street which will remove part of the median. Shoulders have no City-maintained trees.**

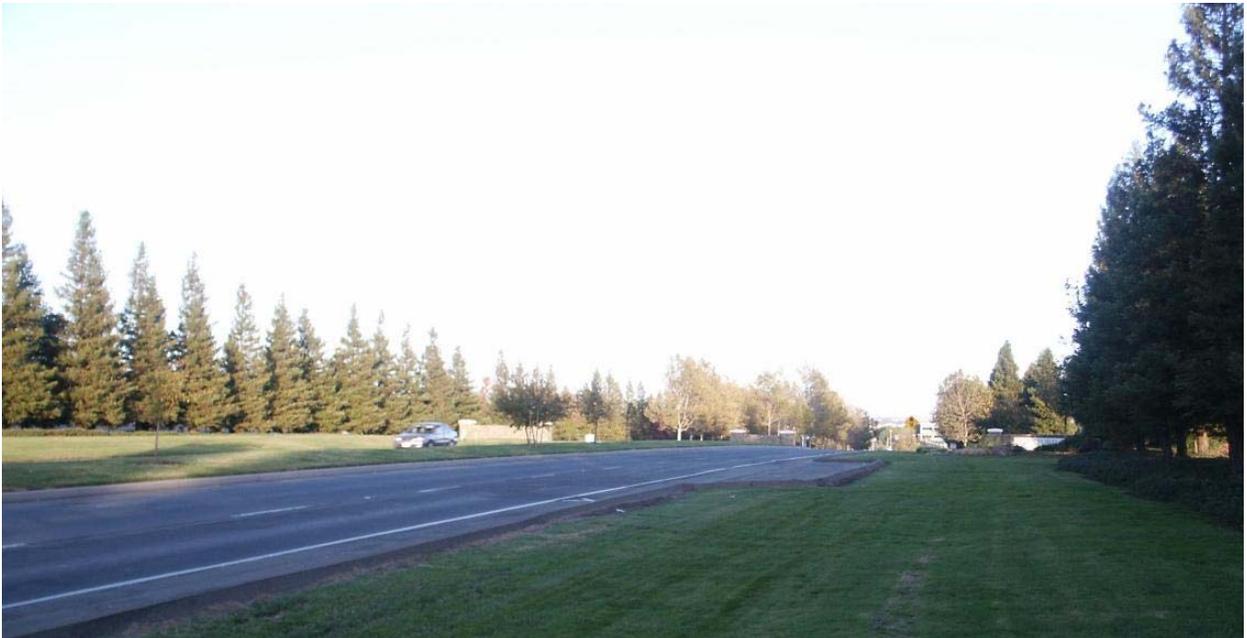
**Figure 3.4-5. Wide planting beds on both shoulders and a center median bed (which is not continuous over the entire surveyed section) on Sunset Blvd. near Atherton. The extra wide shoulder areas are designed to accommodate future lane expansion. Coast redwoods on the left are on private property just beyond the City-maintained shoulder plantings. Most trees in this area are London plane and coast redwoods.**

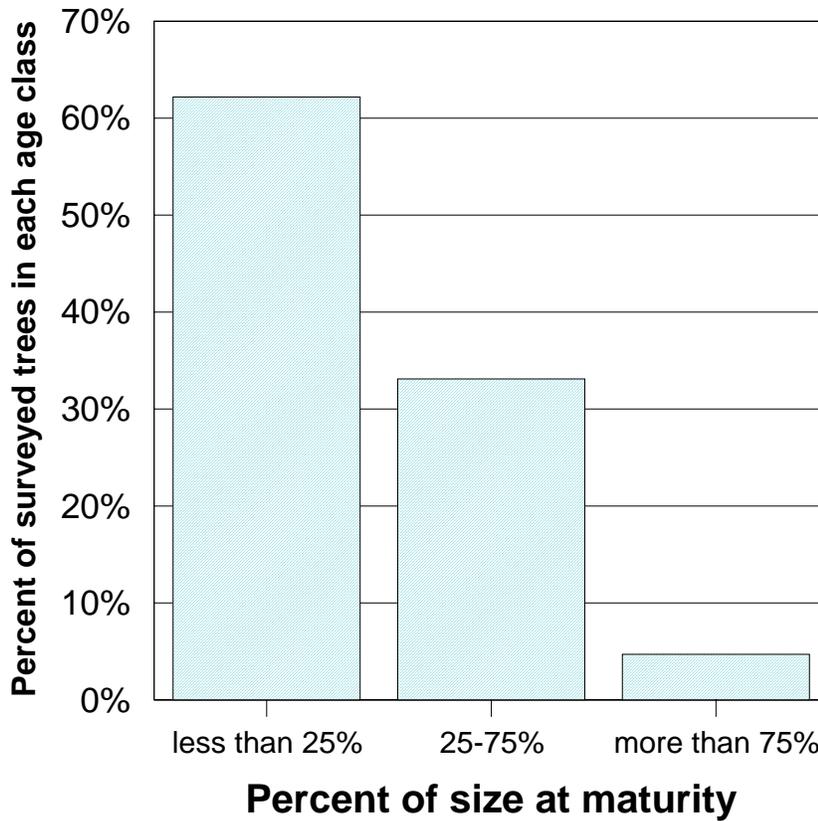
Phytosphere compared current tree size to the typical size of a given tree species at maturity to categorize trees into functional age classes. Most of the surveyed street sections had relatively young tree plantings. Trees had just been installed on the Rocklin Road segment, and many other areas included recently developed or recently renovated planting beds. Consequently, the majority of all trees were rated in the youngest age class, less than 25% of mature size (Figure 3.4-6).

**Figure 3.4-6. Most of the surveyed City-maintained street trees are in the smallest and youngest age class, less than 25% of their mature size.**

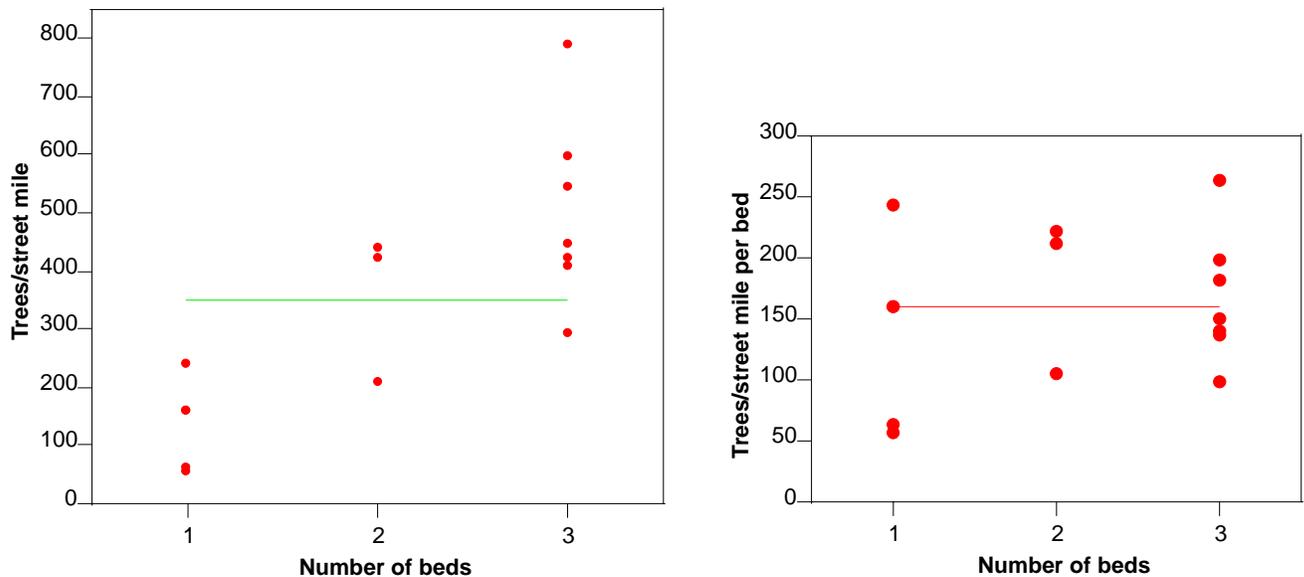
Much of the variation in the number of trees per street mile is associated with the number of landscaped beds per street segment, which ranges from one (e.g., center median only) to three (median plus both shoulders) (Figure 3.4-7). If the number of planting beds is taken into account, the average number of trees per street mile per planting bed is 160, with a

range of 58 to 264 (Figure 3.4-7). This corresponds to an average of one tree for every 40 feet of roadway per landscaped bed.

**Figure 3.4-7. The relationship between tree density and the number of planting beds is illustrated in these graphs. The left graph shows that the number of trees per mile of street increases with the number of planting beds along the street (i.e., center median and/or one or both shoulders). In the graph at right, the tree density of the surveyed street segments have been put on an equivalent basis by dividing by the number of planting beds present. Horizontal lines represent the overall average for all sampled streets in each graph. Variation in tree density between different beds is due to differing planting designs, mature tree size, and site conditions.**

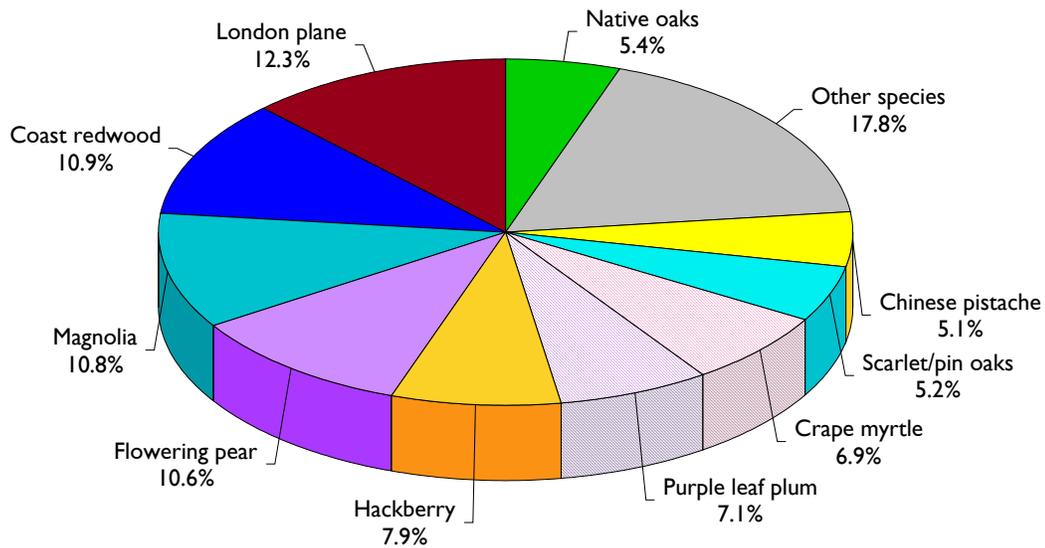
At least 26 species of trees were present within the sampled street segments. However, many of the observed species were represented by only a few individuals. The 12 least common species made up only 8.5% of all surveyed street trees. By comparison, the 5 most common species make up more than 50% of the sample in the survey. This is not surprising given the emphasis on aesthetics and planting uniformity called for in the Street Tree Ordinance and City planning documents. Figure 3.4-8 shows all species that made up at least 5% of the sample.

**Figure 3.4-8. The most common tree species in sampled City-maintained street tree plantings. All species comprising at least 5% of the sample are shown. Three locally native oak species in the sample (blue, interior live, and valley oak) are grouped. Small-statured trees are indicated by stripes; solid colors represent medium to large-statured trees. The ‘Other species’ group includes small to large-statured trees.**

Declining trees were present at nearly the same frequency among all three tree age classes. Among the most common species, shown in Figure 3.4-8, declining or dead trees were found among magnolia, flowering pear, scarlet/pin oak, purple leaf plum, and Chinese pistache.

Irrigation is also a critical maintenance issue. Many of the most common street tree species, comprising over half of the trees in the sample (Figure 3.4-8), have at least moderate irrigation requirements. Coast redwoods, which make up more than 10% of the sample, have a high irrigation requirement. As noted above, street tree plantings tend to be especially stressful because soil conditions are typically poor (high compaction, restricted soil volume) and summer water demand is high due to heat radiated off paved surfaces. In these sites, trees with moderate to high moisture requirements can easily become critically stressed if irrigation is inadequate. Improperly adjusted timers or malfunctioning equipment can result in water deficits that can severely damage established trees and can kill young trees.
