# ASSESSMENT OF THE CITY'S EXISTING STORMWATER CONVEYANCE SYSTEM

**Report**

**City of Rocklin**

**Michael Baker International**

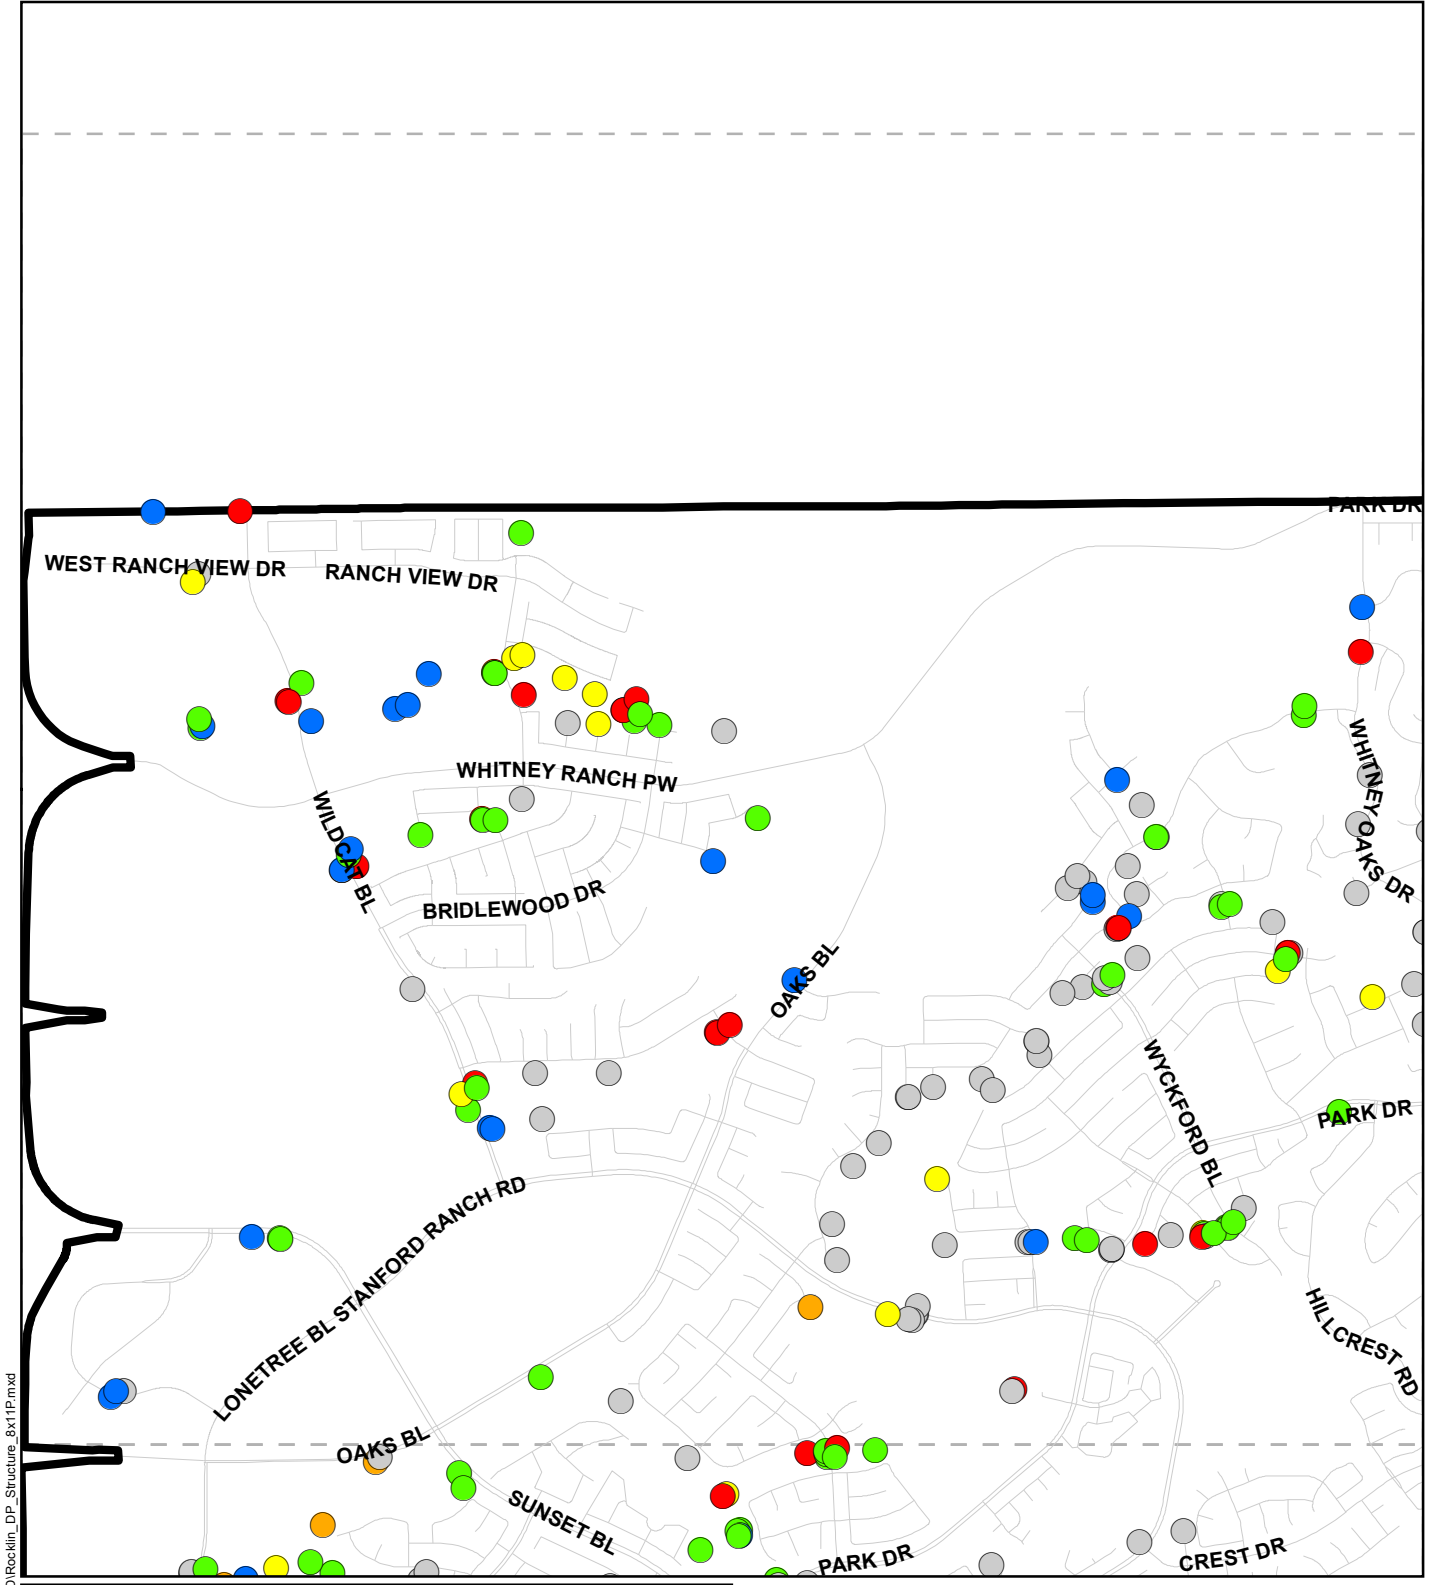
CITY OF ROCKLIN  
**Structure Conditions NW**

Exhibits 6 through 9 depict the location of each outlet structure in the City's storm drain system and color code each structure with its structural condition score. It is noted that all of the outlets are shown on the exhibits, with the label "Not Visited" indicating the facility is either private, could not be found, or could not be accessed for a variety of reasons.

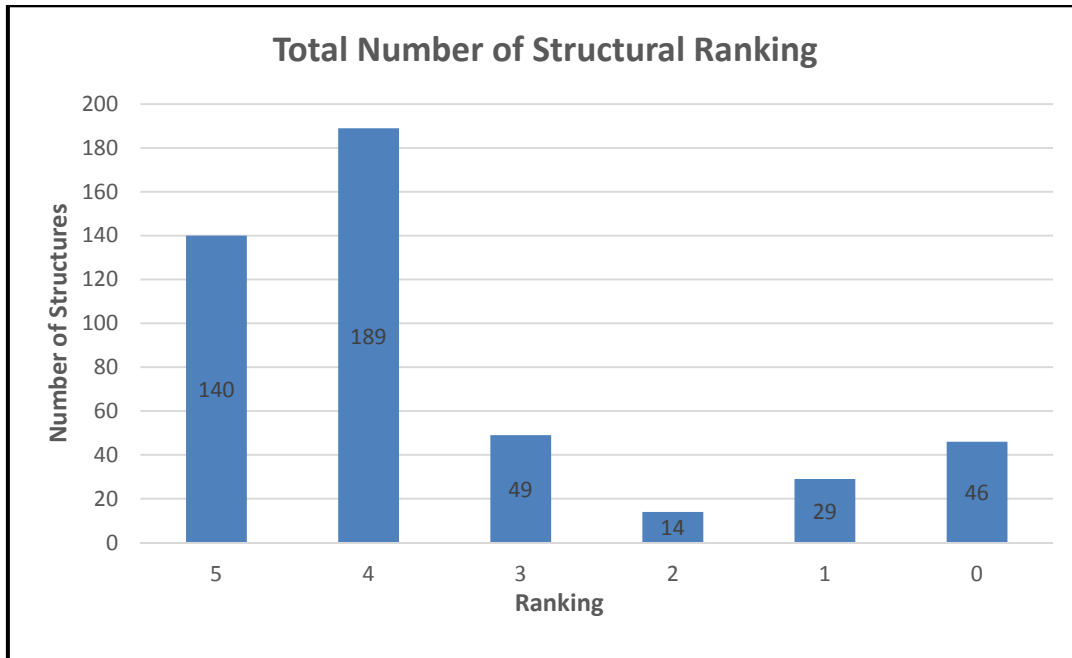
**Graph 1 – Summary of Structural Ranking**

Based on the discharge outlet condition assessment, 43 structures assessed were dilapidated and in poor condition, and thus ranked as a 1 or 2. These structures constitute 9% of the City’s total outlet structures.

The 43 structures identified in poor condition were further evaluated and stratified into three priority categories: 39% or 17 structures appear to be severely damaged, 26% or 11 structures are moderately damaged, and 35% or 15 of the structures are damaged to a certain degree. Further analysis of the structural findings is provided in Section 7.4 of this report.

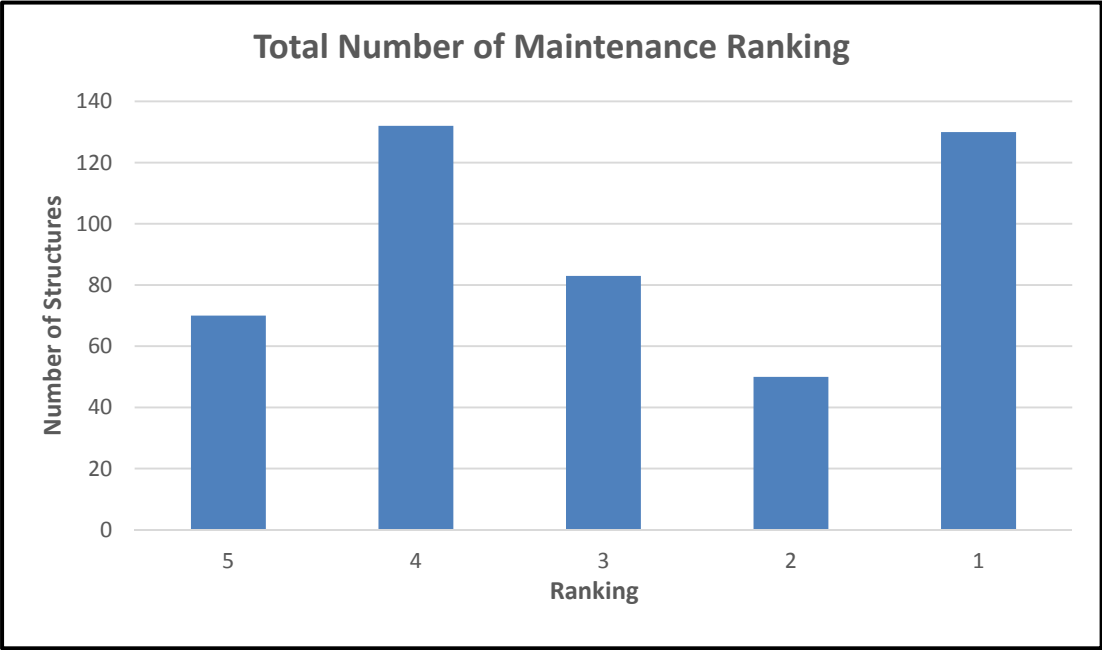
**Graph 2 – Summary of Maintenance Ranking**

Based on the field condition assessment, it was observed that 39% or 180 structures visited required immediate maintenance and were assigned a maintenance ranking of 1 or 2. Reference Table 2 and Graph 2 for a summary of findings of the maintenance assessment. It is recommended that the structures ranked 1 and 2 during the maintenance assessment be cleared of debris to allow proper functioning of the system.

The maintenance assessment concluded that 180 outlet structures, or approximately 39% of the current system, that are ranked 1 or 2 should be immediately cleared and cleaned. The remaining 61% of the outlets require a maintenance plan that should be coordinated with the maintenance plan for the upstream pipes for flushing, cleaning, and CCTV investigation or pipe repair, rehabilitation, or replacement.
